SUBJ: EPA Asbestos Removal at 215 Eden Street

REMOVAL ACTION STATUS REPORT DAVIDSON ASBESTOS

Property Address: 215 Eden Street, Davidson, Mecklenburg County, North Carolina

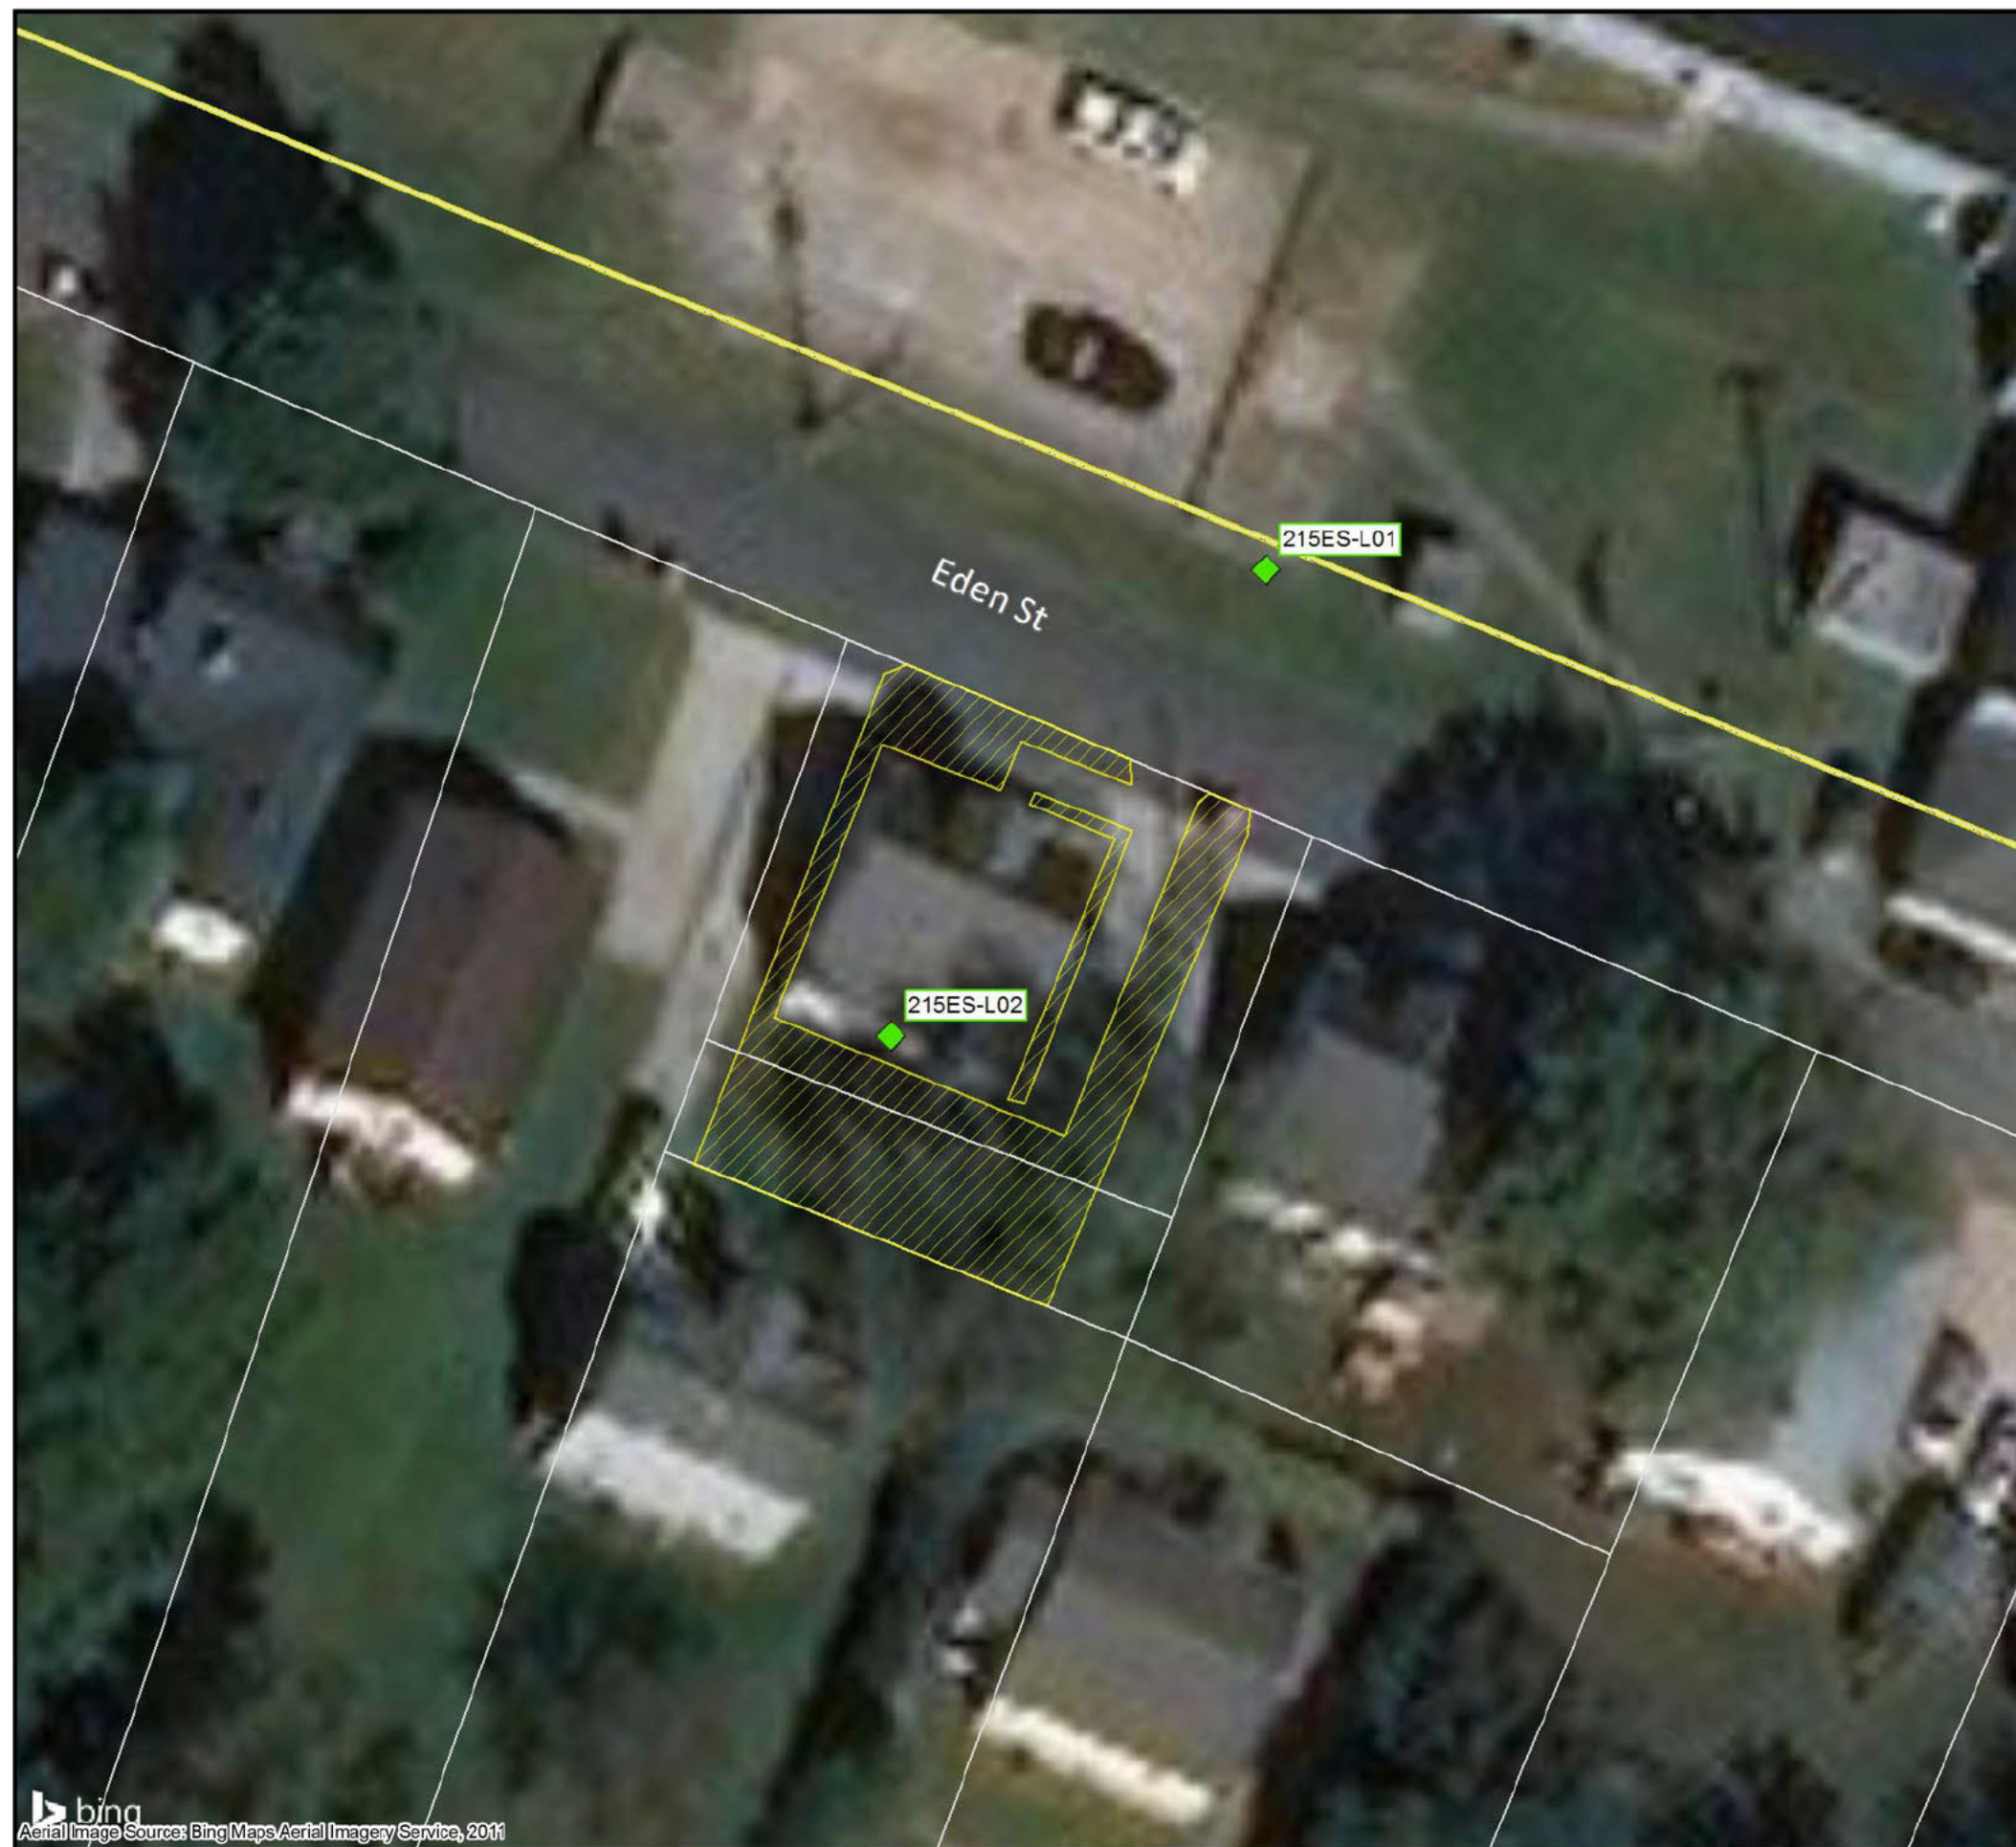
FIGURE 1

Description of Removal Action: The soil was excavated to an approximate maximum depth of 12 inches in the lawn around the residence and 3 inches along the tree and residential drip lines (see Appendix 1). Visual inspections of the areas excavated for asbestos-containing materials (ACM) were conducted by a State of North Carolina-accredited asbestos inspector and air monitor. Additional removal was conducted in those areas where ACM were still visibly present. Once ACM was no longer visibly present, restoration of the excavated areas was allowed to commence.

Removal Areas and
Air Sampling Locations

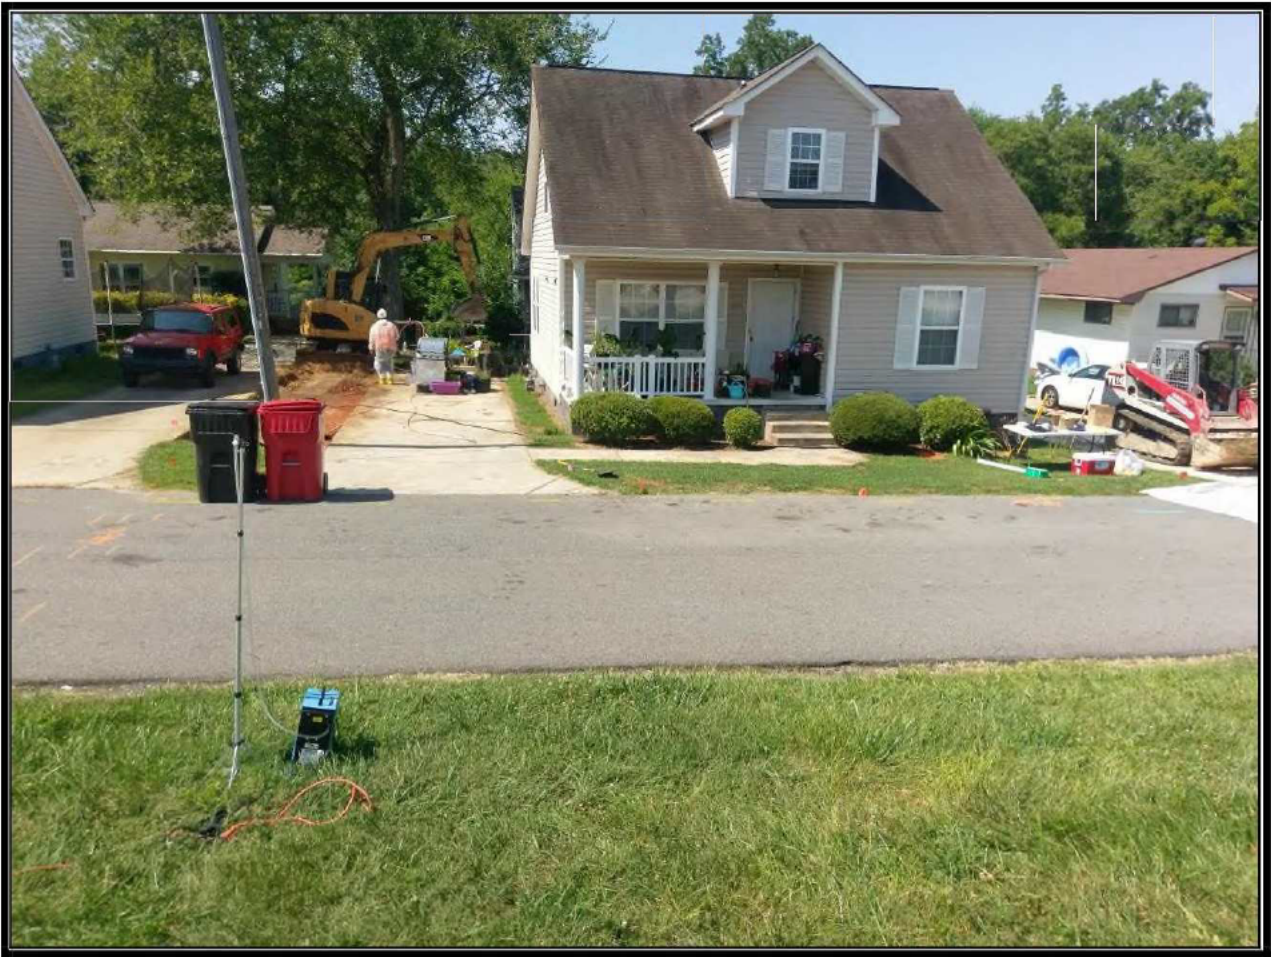
OFFICIAL PHOTOGRAPH NO. 4
U.S. ENVIRONMENTAL PROTECTION AGENCY

Subject: Perimeter air sampling was conducted by a Tetra Tech START, State of North Carolina-accredited air monitor, to evaluate the effectiveness of engineering and safety controls in preventing the off-site migration of asbestos fibers during removal activities.
